The Art of

Pipeline Recovery

Handling environmental issues when asbestos is uncovered

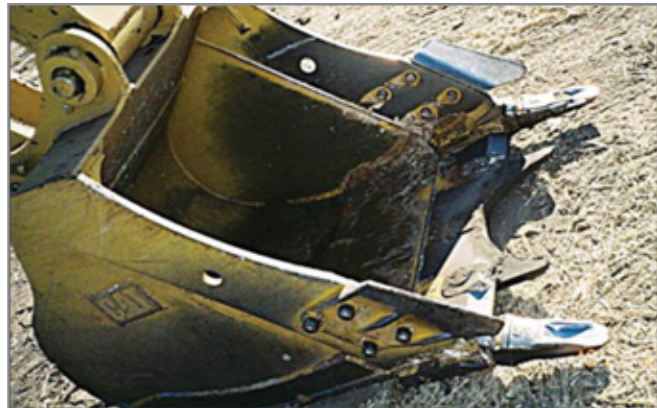
Half-moon spoon used to evacuate and conform 16" pipe.

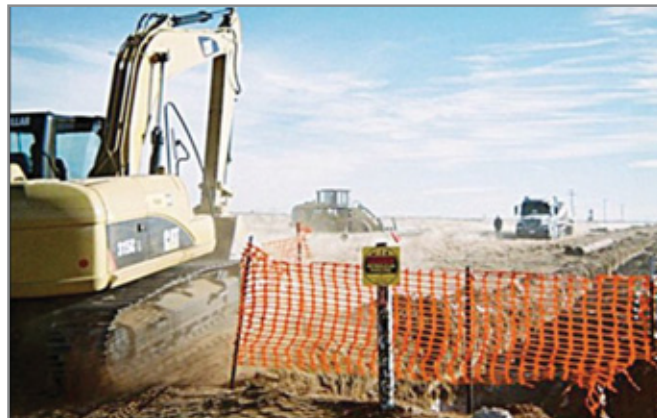
Caution fence at road crossing.

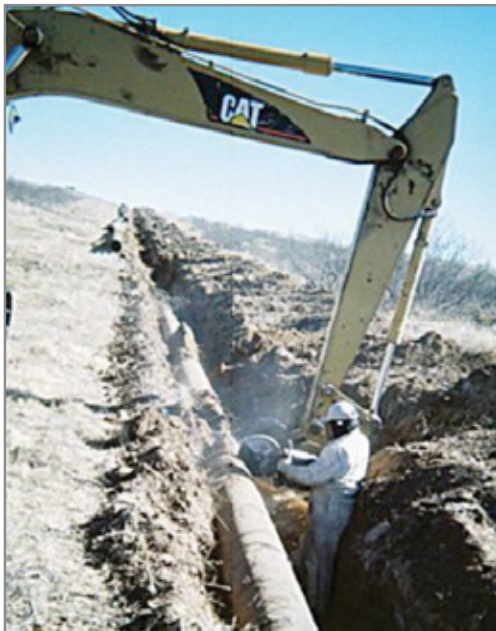
Track hoe lifts pipe to be saw cut. Saws are used instead of torches due to dry grasses in area (fire hazard).

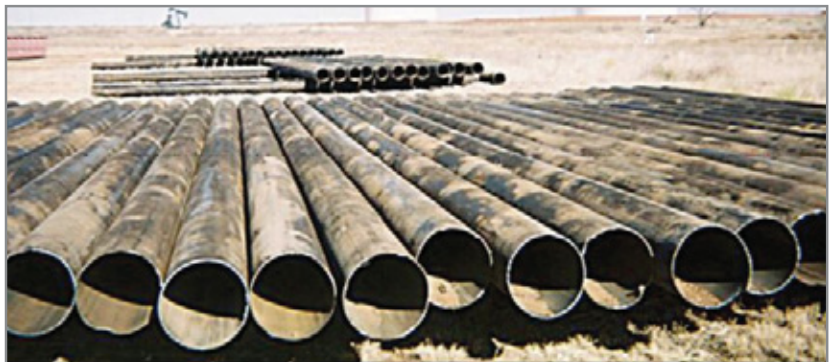
Pipes are cleaned, racked and ready to load.

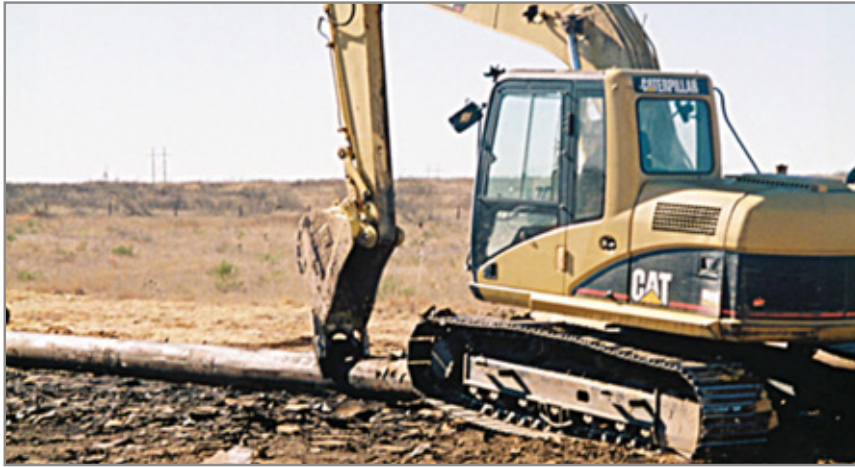
Slice cleaning process.

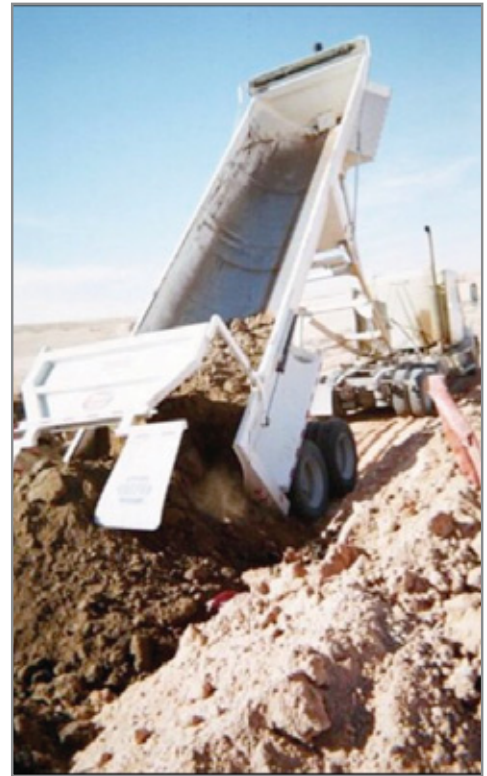
Surface soil right of way disposed of at landfill.

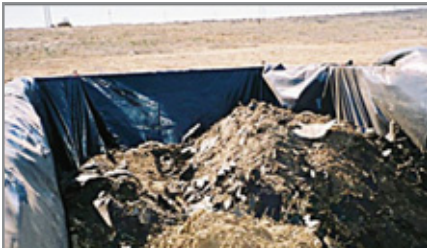
Coating and dirt loaded in lined container for landfill.

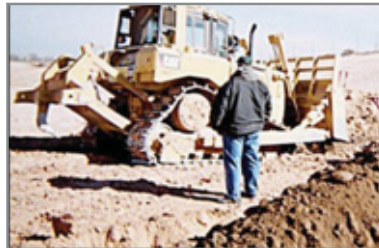
Gathering surface soil.

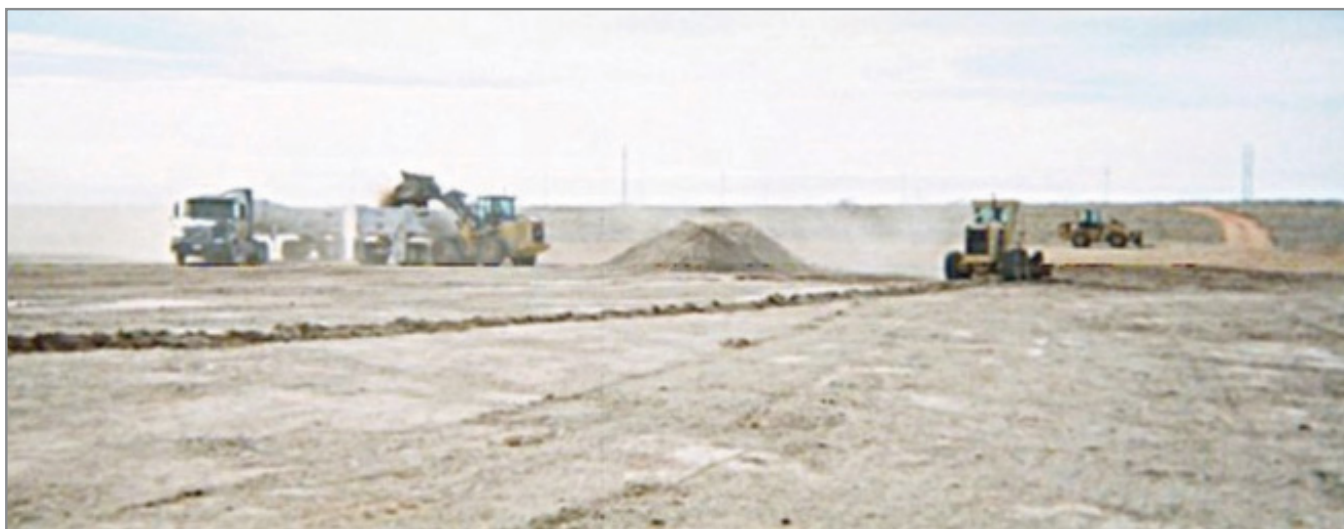
Grading location during final clearing.
